Building damage survey and microtremor measurements for the source region of the 2015 Gorkha, Nepal, earthquake

Masumi Yamada^{1*}, Takumi Hayashida², Jim Mori¹ and Walter D. Mooney³

Keywords: 2015 Gorkha earthquake, Masonry structure, Earthquake damage, Strong motion, Microtremor survey

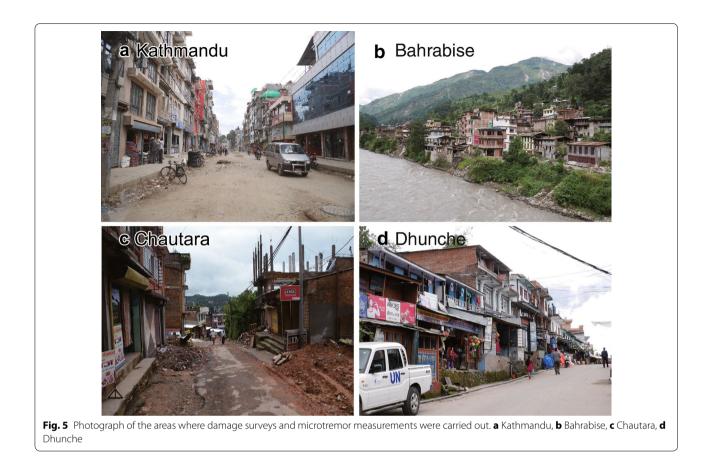
Next we focus on four major population centers (Kathmandu, Bahrabise, Chautara, and Dhunche) and describe the city properties, building types, and damage (see Figs. 5, 6).

high-rise buildings with reinforced concrete structures in the central business district, but the majority of the buildings are masonry structures. The USGS strong motion station is located inside the old embassy building in the Thamel district, in the center of the city. There are almost no totally collapsed structures around the station.

Bahrabise is a village located 60 km east–northeast of Kathmandu, in Sindhupalchowk district. It is located on the Araniko Highway which connects Kathmandu to the Chinese border in the north. The village is developed along this main highway, running along the Sunkoshi River. There are quite a few stone structures in this village. These are made by piled rubble stones and the surface is covered by plaster, with an added decoration of brick pattern on top (EERI and IAEE 2015b). In our field survey, 42 % of buildings were totally collapsed and 11 % were partially collapsed.

Chautara is a municipality located 40 km east-northeast of Kathmandu and headquarters of Sindhupalchowk district. It is a city in a mountainous region with an elevation of approximately 1600 m above sea level. Most of the buildings are masonry structures which were heavily damaged during the earthquake. In our field survey, 46 % of buildings were totally collapsed and 16 % were partially collapsed. Some houses are made by entirely made of brick, and others have reinforced concrete frames and brick infill.

Dhunche is a village located 50 km north of Kathmandu and headquarters of Rasuwa district. It is a village within the Langtang National Park and was popular among hikers before the earthquake. The altitude of the village is about 2000 m. The Pasang Lhamu Highway, connecting Kathmandu and Dhunche, was heavily damaged by landslides induced by the earthquake. In our field survey, 27 % of buildings were totally collapsed and 25 % were partially collapsed. Most of the structures are made of brick, with or without reinforced concrete frames (EERI and IAEE 2015a).

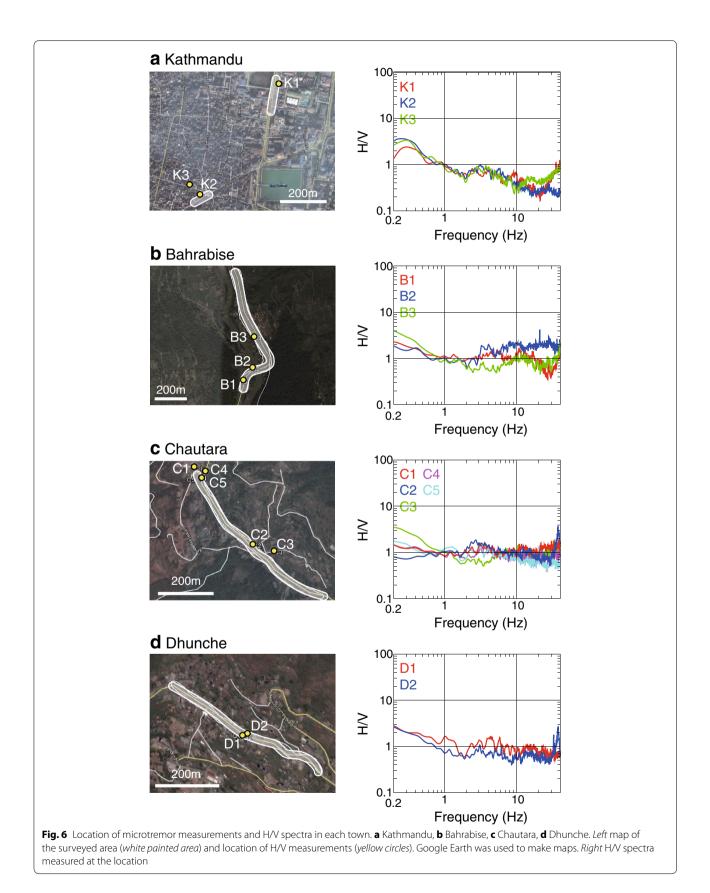
Figure 6 shows the H/V spectra of the ambient noise measured in Kathmandu, Bahrabise, Chautara, and Dhunche. The location of the measurement in Kathmandu is near the USGS strong motion station, and

The H/V spectrum in Kathmandu has a single peak at around 0.3 Hz. The frequency of this peak is consistent with the past studies (Paudyal et al. 2012, 2013) and reflects the velocity contrast of the deep sedimentary basin (Paudyal et al. 2012, 2013; Sakai et al. 2002). This low-frequency basin response is generally consistent with the long-period (0.2 Hz) transient waves that were excited by the Gorkha earthquake, as seen on the strong motion record (Galetzka et al. 2015). The frequency is somewhat different; however, we note that the predominant period of the soil structure tends to become longer under strong shaking.

The H/V spectra in Bahrabise, Chautara, and Dhunche do not show clear peaks, which suggests that there is no strong contrast in the velocity structure. Since these areas located mountainous areas, we think the site conditions are rather stiff and effect of the near-surface amplification is probably not large (Bonnefoy-Claudet et al. 2009).
