Characteristics of the surface ruptures associated with the 2016 Kumamoto earthquake sequence, central Kyushu, Japan

Yoshiki Shirahama^{1*}, Masayuki Yoshimi¹, Yasuo Awata¹, Tadashi Maruyama¹, Takashi Azuma¹, Yukari Miyashita¹, Hiroshi Mori², Kazutoshi Imanishi¹, Naoto Takeda¹, Tadafumi Ochi¹, Makoto Otsubo¹, Daisuke Asahina¹ and Ayumu Miyakawa¹

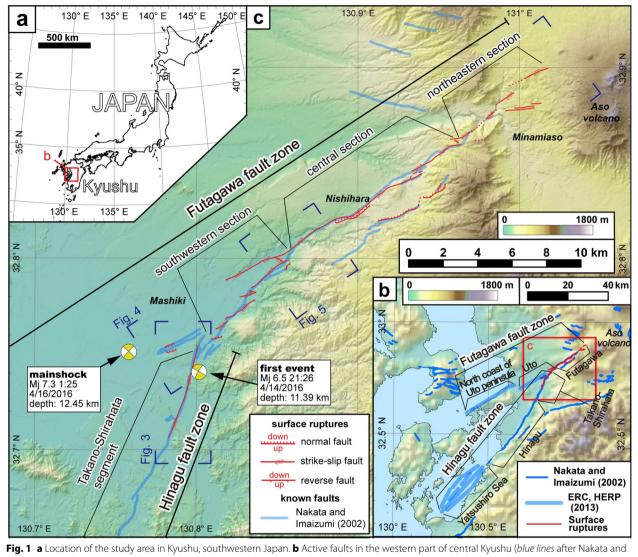
Fig. 1 a Location of the study area in Kyushu, southwestern Japan. **b** Active faults in the western part of central Kyushu (*blue lines* after Nakata and Imaizumi 2002, *light blue lines* after ERC, HERP 2013) and the 2016 surface ruptures (*red lines*). **c** Distribution of surface ruptures associated with the 2016 Kumamoto earthquake sequence observed during our survey (*red lines*), previously mapped active faults (*blue lines*), and the best double-couple solution of centroid moment tensor diagrams for the mainshock and the initial M_J 6.5 event (*yellow beach balls*) determined by the Japan Meteorological Agency, and unconfirmed ruptures interpreted from aerial photographs (Geospatial Information Authority of Japan 2016c) (*dashed red lines*)

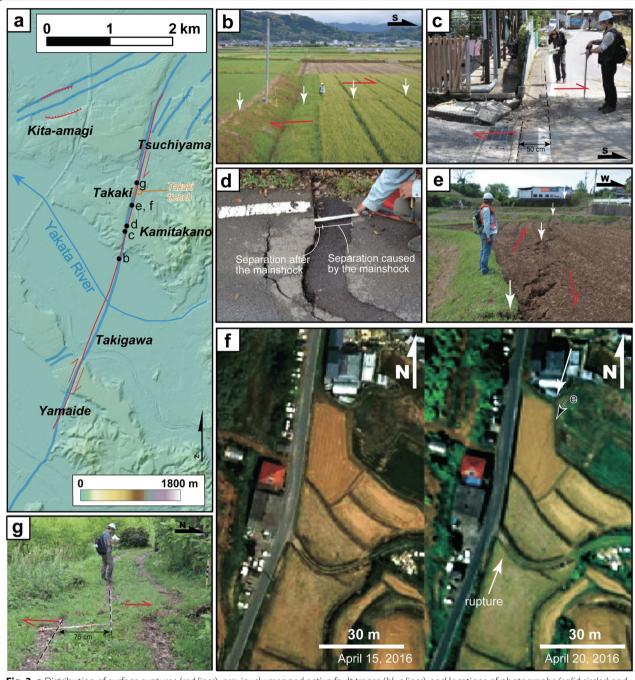
Fig. 3 a Distribution of surface ruptures (*red lines*), previously mapped active fault traces (*blue lines*), and locations of photographs (*solid circles*) and the trench site (*yellow box*) along the Takano-Shirahata segment of the Hinagu fault zone (Fig. 1c). b Cultural features including rows of wheat displaced dextrally (*red half-arrows*) at Kamitakano along the rupture (*white arrows*). c Edge of a road displaced dextrally. d Postseismic activity shown by a crack in a paved road at Takaki. The open crack, filled with asphalt after the mainshock, opened further by the time the photograph was taken on April 28. e Array of left-stepping tension cracks produced by dextral faulting in the alluvial plain at Takaki, as seen on April 16 after the mainshock. f Aerial photographs of Takaki (Geospatial Information Authority of Japan 2016a, b) on April 15 (*left*) and April 20 (*right*). No surface rupture was apparent on April 15, whereas a distinct surface rupture displacing rice paddies and footpaths was discernible on April 20. The *black arrow* shows the location of E. g Dextral offset of wheel tracks by 75 cm on a farm road in Takaki

fault traces (Fig. 3a). Along this segment, the strikeslip component of displacement reached a maximum of 70–80 cm at Takaki (Figs. 3g, 6a) and gradually decreased with distance from Takaki to the north and south. Most ruptures in this segment were left-stepping en echelon arrays of open cracks with little vertical displacement (Fig. 3e), consistent with nearly pure right-lateral strike-slip. The southernmost ruptures, at Yamaide, displayed only a few centimeters of dextral slip. North of Takigawa, ruptures appeared in the alluvial plain on both sides of the Yakata River (Fig. 3b). At Kamitakano, roads, houses, and fields were systematically disrupted by 50–60 cm of dextral offset (Figs. 3c, 6a). In the Takaki area, ruptures in paddy fields coincided exactly with fault traces previously mapped by a paleoseismological survey (Shimokawa and Kinugasa 1999). North of Tsuchiyama, the surface ruptures scattered and then vanished.

We also observed a temporal growth at Takaki. Our first measurements on April 16 indicated dextral displacements of about 50 cm (Fig. 3c), whereas our second measurements on April 28 indicated displacements of about 60 cm. We also found that temporarily repaired cracks in a road crossing the surface rupture had opened further by April 28 (Fig. 3d).

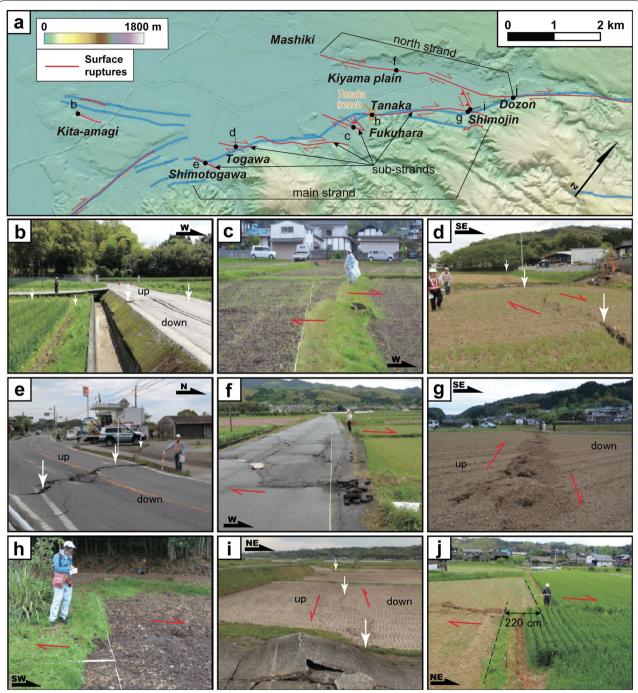
Fig. 4 a Distribution of surface ruptures, previously mapped fault traces, and location of photographs (*black dots*) and the trench survey (*yellow box*) in the Uto segment and the southwestern section of the Futagawa segment of the Futagawa fault zone (Fig. 1c). **b** Surface rupture (*white arrows*) across a road and paddy field at Kitaamagi. **c** Surface rupture at Fukuhara showing dextral displacement of footpath in a paddy field (*red half-arrows*). **d** Left-stepping tension cracks showing a dextral slip in a wheat field at Togawa. **e** Surface rupture across a road at Shimotogawa with the north side downthrown by normal faulting with little lateral slip. **f** Surface ruptures on the north side of the Kiyama plain showing dextral offset of a road and paddy field. **g** Tensional cracks and mole track at Shimojin. The northwestern side of the wheat field was locally upthrown. **h** Dextral displacement at Tanaka along a surface rupture consistent with a fault trace exposed in previous trenching. **i** Surface rupture with sinistral and reverse offset at Shimojin, connecting two left-stepping en echelon dextral ruptures on the northern and southern edges of the Kiyama River alluvial plain. **j** Dextral displacement of a wheat field at Dozon, where the maximum slip of 220 cm was measured

At Kitaamagi, in the easternmost part of the Uto segment of the Futagawa fault zone, we documented two sets of ruptures trending ENE–WSW in an isolated area with 500– 600 m long about 3 km from the nearest surface ruptures in the adjoining Futagawa segment (Fig. 4a). The southern rupture appeared along a preexisting north-facing fault scarp on the northern margin of the Kitaamagi upland (Ikeda et al. 2001; Fig. 4b), displaying approximately 30 cm of south-side-up normal offset and a small amount of dextral offset. A few hundred meters to the north, faint open cracks appeared near a previously mapped south-facing fault scarp.

In the southwestern section of the Futagawa segment, most ruptures displayed 70-100 cm of dextral offset (Fig. 6a). Near Dozon, at the eastern end of this section, ruptures are composed of two strands that bound the Kiyama plain, a 5-km-long north strand along the northern edge and a 7-km-long main strand, along the southern edge of the plain (Fig. 4a). The main strand consisted of a left-stepping en echelon array of five substrands striking NE-SW. These sub-strands displayed dominantly dextral slip and south-side-up normal slip and were separated by releasing stepovers 1-2 km long and 0.5-1 km wide. This complex distribution of the substrands resulted in large scattering of measured displacements of the southwestern section (Fig. 6). The main strand ended just east of Shimojin, and the north strand continued eastward to the main strand in the adjoin central section. The north strand was a relatively continuous and displayed a few restraining double bends. Displacements on the two strands were largest (90-120 cm) at their northeastern tips, and systematically decreased toward the west (Fig. 6a). These two strands constituted a tweezers-shaped pair of splay faults, connected by a NWstriking sinistral-slip rupture near their closest approach (Fig. 4a, i). Most of the surface ruptures were accompanied by left-stepping en echelon arrays of open cracks associated with dextral faulting, sometimes with a small south-side-up normal component (Fig. 4c, d, f, g, h). At ruptures south of Shimojin and in Shimotogawa, the north side was downthrown 40–50 cm by normal faulting (Fig. 4e). Near Shimojin and Fukuhara, pairs of dextral ruptures striking NW-SE were connected by a rupture with sinistral and reverse offsets (Fig. 4a, i). The vertical and horizontal displacements on those sinistral ruptures both systematically decreased toward the northwest. The ruptures along the main strand nearly coincided with the previously recognized fault trace. The north strand was previously recognized as an active fault, Kiyama fault, only estimated by geological analyses of borehole cores (Tsuruta and Watanabe 1978).

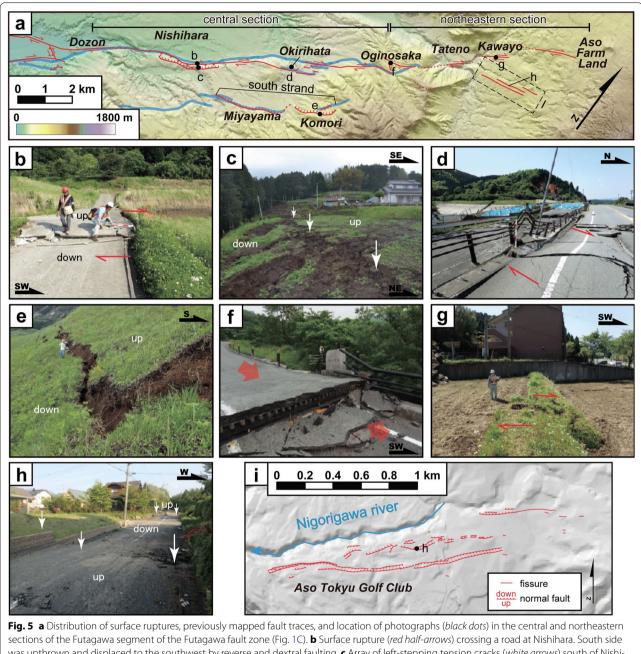
sections of the Futagawa segment of the Futagawa fault zone (Fig. 1C). **b** Surface rupture (*red half-arrows*) crossing a road at Nishihara. South side was upthrown and displaced to the southwest by reverse and dextral faulting. **c** Array of left-stepping tension cracks (*white arrows*) south of Nishihara related to dextral and normal faulting on the hillside. **d** Surface rupture crossing a road at the Okirihata dam showing dextral slip. **e** Surface rupture at Komori with the north side downthrown by normal faulting. **f** Surface rupture crossing the bridge at Oginosaka which was compressed by dextral faulting (*red arrows*). **g** Surface ruptures at Kawayo showing dextral offset of a field and footpath. **h** A small graben crossing a road, defined by surface ruptures in the foreground and background. **i** Surface ruptures and fissures (*red lines*) near the Nigorigawa River that defined small grabens

Along the 8-km-long northeastern section of the Futagawa segment, ruptures consisted of several en echelon arrays and gradually decreased in displacement toward the northeast (Figs. 5a, 6a). The central and northeastern sections were separated at Oginosaka by a stepover 2 km long and 1 km wide, connected by NW-striking ruptures with sinistral displacement, similar to stepovers described in the southwestern section near Shimojin and Fukuhara.

At Oginosaka, on the north side of the stepover, a rupture oriented ENE–WNW passed beneath a bridge oriented E–W, where about 200 cm of compression damaged the abutments (Fig. 5f). On the south side of the stepover, east of Oginosaka, an extensional branch rupture was observed in aerial photographs taken on April 16 (Geospatial Information Authority of Japan 2016c). From Tateno to the end of the rupture, three strands 1–2 km long constituted an en echelon array separated by releasing stepovers 100–500 m wide. The dextral displacement decreased along this array from 140 cm at Tateno and 120 cm at Kawayo (Fig. 5g) to 80 cm at Aso Farm Land and several centimeters at the eastern end (Fig. 6a).

Another E–W trending branch rupture 2.5 km long appeared south of Kawayo (Fig. 5a, i). This branch was a zone of sub-parallel fissures and grabens (Fig. 5h, i). Although much of the natural topography had been artificially modified, some of these grabens appeared to coincide with preexisting small valleys.
