## Landform and local site effects on the colonies worst-hit by the 2004 mid-Niigata prefecture, Japan, earthquake

Landform and damage classification surveys have been conducted on six colonies worst-hit by the 2004 mid-Niigata prefecture earthquake. The landform was classified using aerial photographs taken by the US Air Force in 1947. Damage degree of each structure has been classified into four classes including foundation damage class, and location of each structure has been mapped with damage class. Around 1,000 houses and stores have been classified and mapped. In five of six colonies, buildings on the fans composed of colluvial deposits have been more likely suffered severe damage than those on terraces or dissected valleys. In the other colony located on a flood plain, no clear difference in degree of damage among landforms has been observed.

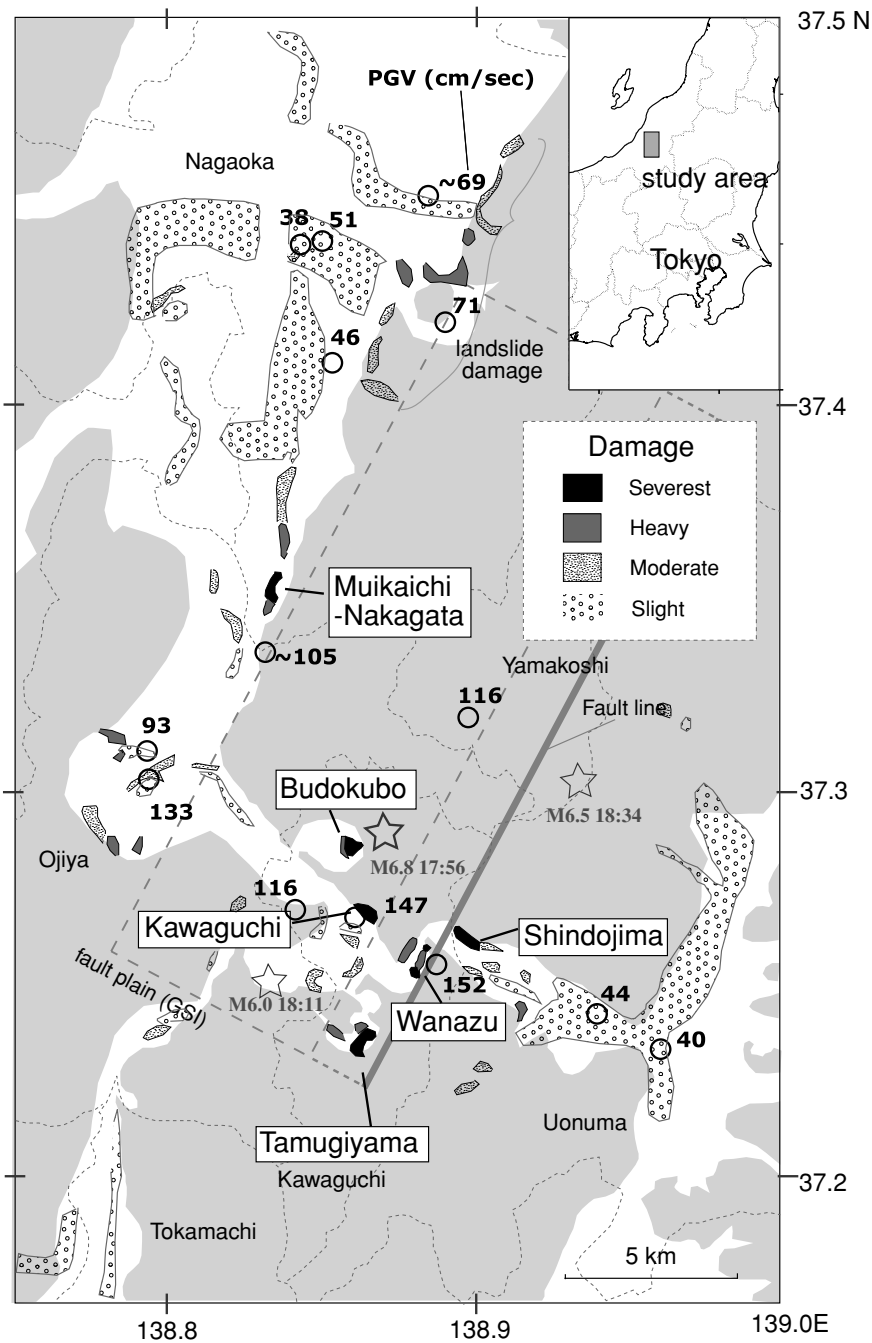
Soon after the shock, from October 28th until November 3rd, we conducted a quick field survey on damage distribution of buildings, mainly wooden houses or barns, in the focal area. We found that most of heavily damaged colonies were located in an area within 10 km from the epicenter of the main shock (Fig. 1). Among those heavily damaged colonies, we recognized six worst-hit colonies (Muikaichi-Nakagata, Budokubo, Kawaguchi, Tamugiyama, Wanazu and Shindojima), where more than 20% of houses had been totally collapsed by shaking. Though the area of each worst-hit colony was no more than 1 km<sup>2</sup>, clear contrast in severity of damage among subregions was observed. These indicated that there could have been local amplification in those heavily damaged or worst-hit colonies.

Strong ground motions for the main shock have been recorded in the focal area. Peak ground velocities (PGVs) are shown in Fig. 1. As a whole, these PGVs agree well with general feature of the damage distribution: no heavily

damaged colonies are found in an area with PGV less than 50 cm/s, and the largest and the second largest PGV, 152 cm/s and 147 cm/s, is found at one of the worst-hit colonies, Wanazu and Kawaguchi, respectively. However, even around an area with PGV more than 100 cm/s, we did still observed slightly or moderately damaged colonies.

Fig. 1. Damage distribution in the focal area of the mid-Niigata prefecture earthquake obtained by our quick survey. Worst-hit colonies are shown as patches in black color. Stars represent the epicenters of the main shock and major aftershocks (Japan Meteorological Agency, 2004). Tilted rectangle with broken lines shows surface projection of the seismic fault plain deduced from leveling data (Geographical Survey Institute Japan, 2004). Each number with a blank circle is peak ground velocity at a location denoted with the circle recorded by JMA, National Institute for Land and Infrastructure Management, National Research Institute for Earth Science and Disaster Prevention, Japan Highway Public Corporation, East Japan Railway Company, Niigata prefecture or Horinouchi Gas Public Company. Domains colored with light gray represent mountain areas and hill areas.

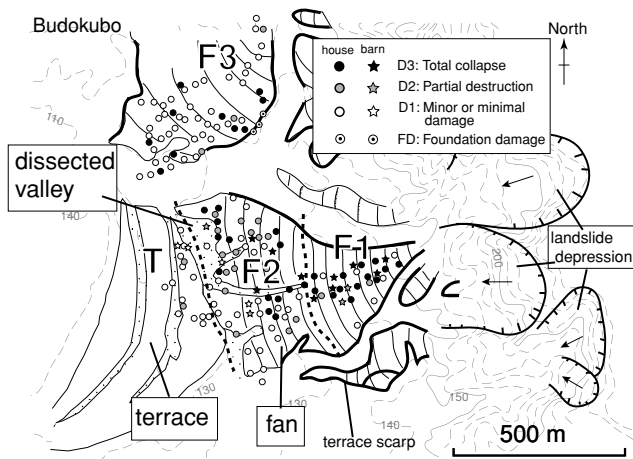
Fig. 2. Landform and damage distribution in Budokubo area. Each house and barn is respectively mapped with circle and star with colors showing damage degree; black: total collapse, dark gray: partial destruction and white: minor or minimal damage, respectively. Bull's eye shows a structure damaged by slumping or slanting of foundation. Buildings on the fan, especially on subregion F1, were more likely suffered severer damage than those on the terrace and dissected valleys. Contour data (10 m interval) in light gray are from the 1:25000 topographic map "Ojiya", and partly from the 1:10000 topographic map published by Kawaguchi town.

Budokubo colony is located on an old meander channel of Shinano River, surrounded by hills consisting of Pliocene mudstone and sandstone with well-developed landslide topographies. A landform classification map of this area is shown in Fig. 2. Main landforms are terrace, fan, dissected valley and terrace scarp. The terrace consists of fluvial gravels 5 to 40 cm in diameter. On the other hand, the fans are composed of unconsolidated colluvial deposits supplied from the surrounding hills. Fan deposits are about 10 m thick. The lower part of the deposits includes the 26 ka Aira-Tn tephra, implying that the fans were formed during or after the last glacial stage.

We found that 37 houses and 10 barns, among 150 houses and 18 barns, have suffered total collapse. Damage distribution is shown in Fig. 2 and component ratios of damage classes of houses are listed in Table 1. It is implied that the severity of damage has been affected by landforms. Houses on the fan, especially on its upper part, tended to suffer severer damage than those on the terrace, where no total col-

lapse (D3) has been observed. This suggests that the ground motion on the fan, especially on its upper part, has been greater than that on the terrace.

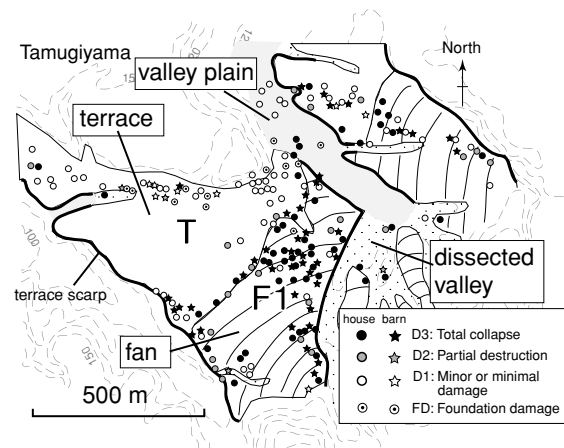
Fig. 3. Landform classification and damage distribution in the Tamugiyama area, likewise as Fig. 2. Buildings on fans were more likely suffered severer damage than those on terraces. F1 is the subregion where the severest damage was observed. Contour data (10 m interval) in light gray are from the 1:25000 topographic map "Iwasawa".

Tamugiyama colony is located on an old meander channel of Uono River, a branch of Shinano River, surrounded by hills composed of Pliocene or Pleistocene sandstone with well-developed landslide topographies. Terrace, fan, dissected valley, valley plain and terrace scarp represent landform of this area as shown in Fig. 3. The terrace deposits mainly consist of gravels interbedded with silt beds, sand and mud. The gravel beds contain pebbles and cobbles of chert and metamorphic rocks derived from the upper reaches of the Uono River. The silt beds intercalate the Aira-Tn tephra. The fans consist of unconsolidated colluvial deposits containing an intercalated Aira-Tn tephra layer. Each fan surface curves convexly and slopes more steeply in the lower part. The terrace is almost flat, gently sloping down to dissected valleys.

We found that 55 houses and 42 barns, among 152 houses (including some stores) and 54 barns, have suffered total collapse. Damage distribution is shown in Fig. 3 and component ratios of damage classes of houses are listed in Table 2. It is shown that damage degree was sensitive to landforms. Houses on the fans tended to suffer severer damage with total collapse (D3) ratio of 59%, than those on the terraces with total collapse ratio of 16%. Above all, severest damage was observed on the steeply sloping subregion of

the southern fan (F1 in Fig. 3). This suggests that the amplification of ground motion on the fans, especially on the subregion with steeper slope, has been greater than that on the terrace.

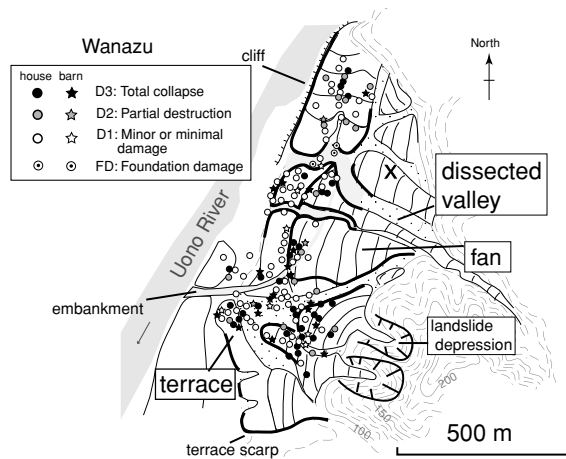
Fig. 4. Landform classification and damage distribution in Wanazu area, likewise as Fig. 2. Buildings on the fans tended to be damaged heavier than those on the terraces. Capital X denotes the location where ground motion with PGV 152 cm/s was observed by East Japan Railway company. Contour data (10 m interval) in light gray are from the 1:25000 topographic map "Obiroo".

Wanazu colony is located nearby the narrowest point of Uono River and surrounded by hills composed of Pliocene or Pleistocene sandstone with well-developed landslide topographies. Terrace, dissected valley and fan characterize landform of this area as shown in Fig. 4. The terraces are covered with the fans. From the topographical point of view, the fans and the terraces are inferred to be composed of colluvial deposits supplied from surrounding hills and fluvial deposits, respectively. Ground motion with PGV 152 cm/s was observed at the location denoted with capital X in Fig. 4.

We found that 35 houses and 18 barns, among 130 houses and 28 barns, have suffered total collapse. Damage distribution is shown in Fig. 4 and component ratios of damage

classes of houses are listed in Table 3. Damage distribution in this area shows complicated manner in contrast with that in Tamugiyama or Budokubo. Comparison of the component ratios implies that the severity of damage has been affected by landforms. Houses on the fans tended to be damaged heavier than those on the terraces. This suggests that the ground motions on the fans have been more amplified than those on the terraces.

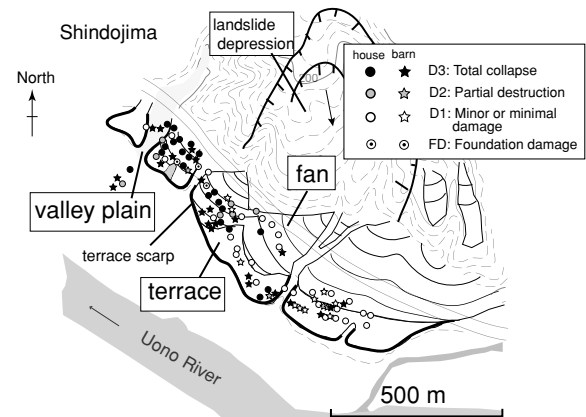
Fig. 5. Landform classification and damage distribution in Shindojima area, likewise as Fig. 2. Buildings on the western subregion were more likely suffered severer damage than those on the eastern subregion. Contour data (10 m interval) in light gray are from the 1:25000 topographic map "Obiroo".

Shindojima colony is located on the foot of a hill covered with Pliocene or Pleistocene sandstone and faces to Uono River. Landslide topographies are well developed on the hill. Terrace, fan and dissected valley represent landform of this area as shown in Fig. 5. The terraces are overlaid by the fans. The fans are inferred to be composed of colluvial deposits supplied from the hill on the back. The fan surface slopes steeper in the western part and gentler in the eastern part.

We found that 21 houses and 21 barns, among 58 houses and 35 barns, have suffered total collapse. Damage distribution is shown in Fig. 5 and component ratios of damage classes of houses are listed in Table 4. The total collapse ratios of houses on the fans and on the terraces are 42% and 19%, respectively. In addition, totally collapsed houses were tended to concentrate on the steeply sloping western part of the fan. These indicate that the ground motions on the fans, especially on the steeper western part, were greater than those on the terraces.

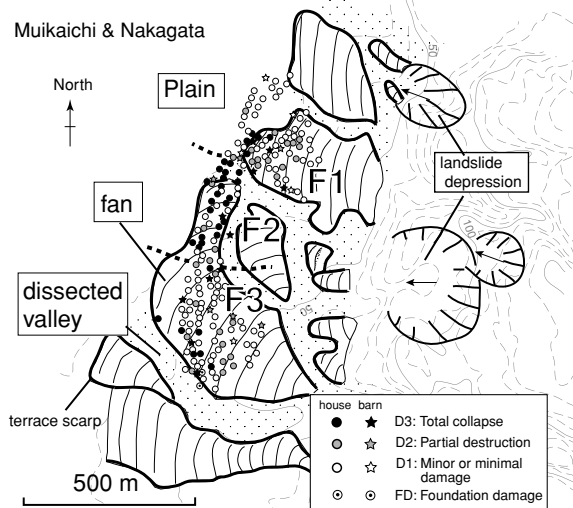
Fig. 6. Landform classification and damage distribution in Muikaichi-Nakagata area, likewise as Fig. 2. Buildings on subregion F2 were more likely suffered severer damage than those on the plain, and subregions F1 and F3. Contour data (10 m interval) in light gray are from the 1:25000 topographic map “Katagai”.

veloped on the right bank of Shinano River. Hills with well-developed landslide topographies composed of Pliocene or Pleistocene sandstone lie in the east. Fan, dissected valley and alluvial plain represent landform of this area as shown in Fig. 6. The fans in this area can be separated into three subregions: the northern fan (F1), the northern part of the main fan which is about 100 m wide (F2), and the southern part of the main fan (F3). The scarp at the southern edge of F3 is 5 m high. The scarp at the northwestern edge of F1 is about 2 m high.

We found that 33 houses and 10 barns, among 177 houses and 22 barns, have suffered total collapse. Damage distribution is shown in Fig. 6 and component ratios of damage classes of houses are listed in Table 5. Total collapse ratio is the highest on subregion F2. It is noteworthy that ratio of total collapse on subregion F2 is about five times higher than those on the other subregions on the fans. This implies that ground motion was much amplified on F2. As subregion F2 is narrow and the others are not, this narrow shape might have caused local amplification.

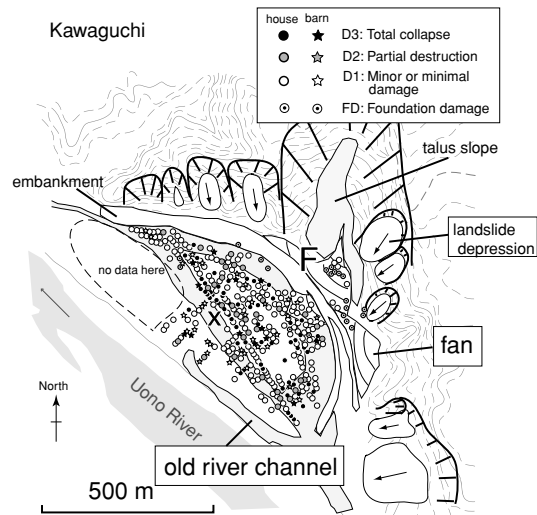
Fig. 7. Landform classification and damage distribution in Kawaguchi area, likewise as Fig. 2. Buildings on hillside F tended to be destroyed by foundation failure. Most of severely damaged buildings on the plain were old. Capital X denotes the location where ground motion with PGV 147 cm/s was observed by Niigata Prefecture. Contour data (10 m interval) in light gray are from the 1:25000 topographic map “Ojiya”.

in the plain (Fig. 7). The plain slightly slopes down toward the river. An embankment of a railway lies on the border between the hill and the plain. Ground motion with PGV 147 cm/s was observed at the location denoted with capital X in Fig. 7.

We checked 285 houses and stores and 46 barns on the plain excluding northwestern subregion, and 19 houses on the hillside. We found that 61 houses and 13 barns on the plain have suffered total collapse and that most of houses on hillside have been destroyed by foundation failure. Most of severely damaged structures on the plain were old, as reported in other investigations (Sakai *et al.*, 2005; Hisada, 2005). Damage distribution is shown in Fig. 7 and component ratios of damage classes of houses are listed in Table 6.

Severely damaged houses were unevenly distributed in the plain. This unevenness was considered to be related to the distribution of aging houses. We, here, conclude that there have been no clear differences in damage degree between landforms in the plain.

Since the damage was significant in this colony compared to those of other colonies nearby, which are located on terraces, the flood plain might have amplified the ground motion.
