The large tsunami of 26 December 2004: Field observations and eyewitness accounts from Sri Lanka, Maldives Is. and Thailand

Key words: Sumatra earthquake, Indian Ocean tsunami, field observations, eyewitness accounts, Sri Lanka, Maldives Is., Thailand.

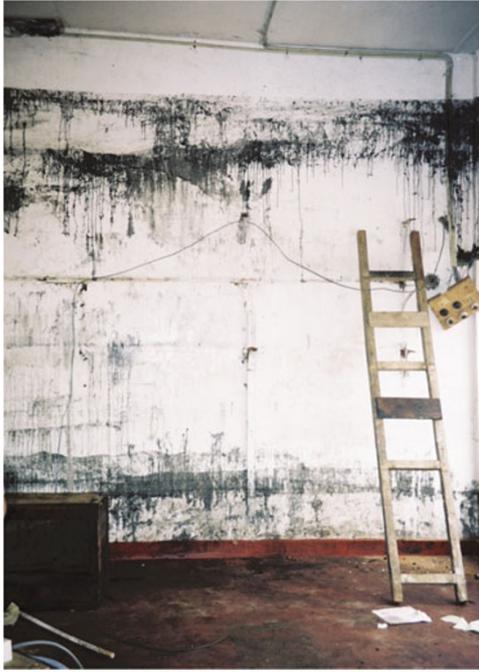
Fig. 4. Characteristic indoor sea sand mark left behind by the tsunami in the coastal zone of downtown Hambantota, south Sri Lanka. This is one of the locations where the maximum water level of $h \sim 11$ m was measured.

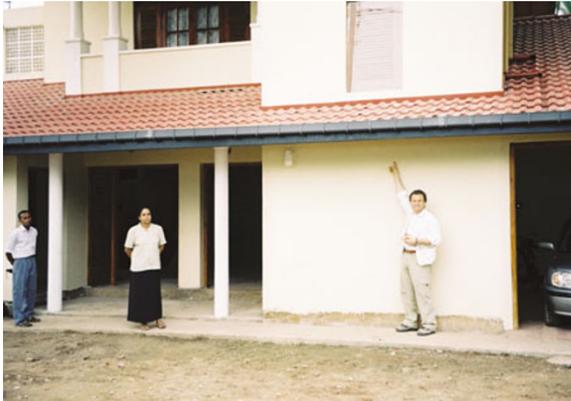
Fig. 5. Two-storey RC house that resisted very well the tsunami attack at distance of ~ 80 m from the shoreline of Paralyia, southwest Sri Lanka. Only little damage was caused in doors and windows. Water mark was left on wall.

Figures 5 and 6 show a characteristic example of one nRC and one RC building situated at exactly the same spot of observation at a distance of about 80 m from the shoreline of Paralyia, southwest Sri Lanka: the nRC building was completely demolished by the tsunami, while the RC one resisted very well and only minor damage was noted on it.

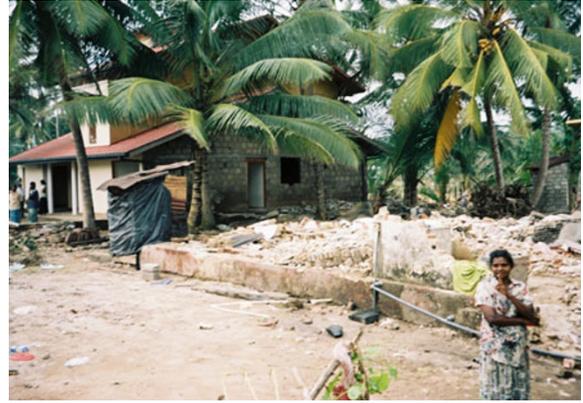
Fig. 6. Non-RC brick-work house completely demolished by the tsunami in Paralyia, southwest Sri Lanka. In the left-hand side the RC house (Fig. 5) makes strong contrast.

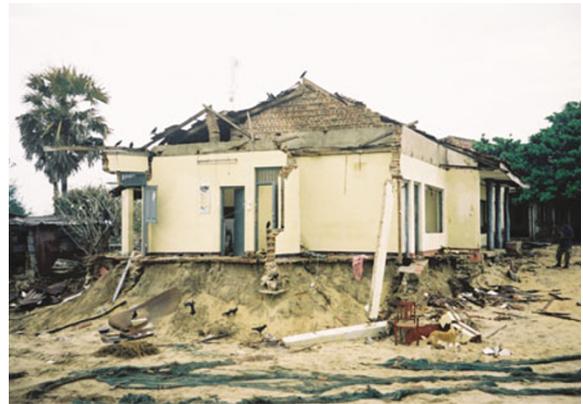
Fig. 7. The soil erosional action of the tsunami caused the sea-facing side of the non-RC building to collapse (~ 120 m from beach, near Karativu, east Sri Lanka).

The tsunami erosional action in soil was a factor of destruction in buildings and infrastructure. Buildings with eroded foundations typically tilted, and because of this were damaged or even were collapsed (Fig. 7). Along railways erosion caused the embankment either to collapse or to spread laterally (Fig. 8). Because of this the railway system along the coastal zones hit by the tsunami was destroyed in many localities. Tens of bridges were also destroyed because either of the hydrodynamic force of the wave or its erosional action at the base of the bridge or both (Fig. 10).

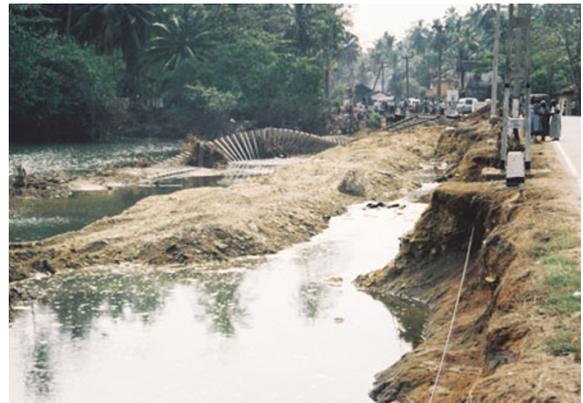
Fig. 8. Complete failure of railway due to lateral spreading and collapse of its embankment caused by the soil erosional action of the tsunami (Abalangoda, southwest Sri Lanka). The tsunami wave moved from the right-hand side to the left-hand side of the picture.

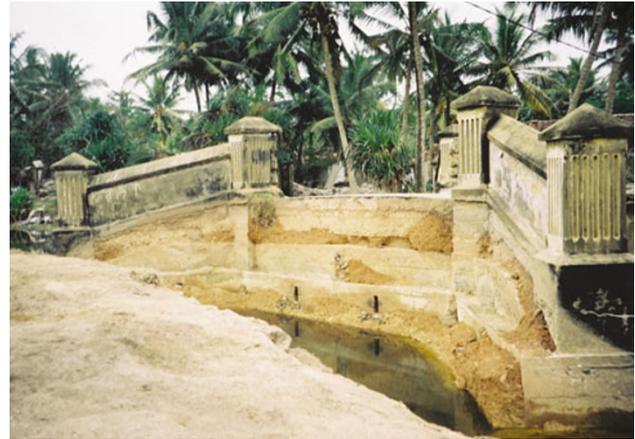
Fig. 10. The soil erosional action along with the force of the hydrodynamic flow of the tsunami caused collapse of one side of bridge (North Kalutara, southwest Sri Lanka).
