Building damage survey and microtremor measurements for the source region of the 2015 Gorkha, Nepal, earthquake

Masumi Yamada^{1*}, Takumi Hayashida², Jim Mori¹ and Walter D. Mooney³

Keywords: 2015 Gorkha earthquake, Masonry structure, Earthquake damage, Strong motion, Microtremor survey

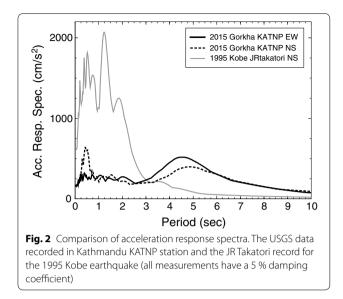
Although there were many reports of severe damage to older historical structures (e.g., Goda et al. 2015), we focused on the modern houses and shops for consistency. In transit to the various towns, we also recorded the percentage of totally collapsed buildings with a visual inspection from the vehicle. These records may be less precise and are shown with small circles in Fig. 3a.

The percentage of the totally collapsed buildings in each site is shown in Fig. 3a. Damage of buildings in the Kathmandu valley was localized (Bhaktapur, Sanku, and near the bus terminal in Kathmandu city), and the percentage of the totally collapsed buildings was less than 5 % in the entire valley (personal communication from the Department of Mines and Geology, DMG). East of the Kathmandu valley, especially in Sindhupalchok district, damage of buildings was severe. In the towns of Chautara and Bahrabise, the percentage of the totally collapsed houses exceeds 40 %. There were also totally destroyed small villages observed on the way to those towns. North of the Kathmandu valley, the damage was moderate, with 20–30 % of the buildings totally collapsed in the towns of Betrawati and Dhunche.

Figure 3a also shows the fatalities in each district with the background color (The Ministry of Home Affairs, Government of Nepal 2015). The distribution of the heavily damaged villages was consistent with the distribution of fatalities. The most fatalities are in Sindhupalchok district, where more than 3000 people were killed (The Ministry of Home Affairs, Government of Nepal 2015). In our damage survey, two towns in the district (Chautara and Bahrabise) were severely damaged with 40 % of the totally collapsed buildings. This suggests that the substantial fatalities were caused by the collapse of the structures.

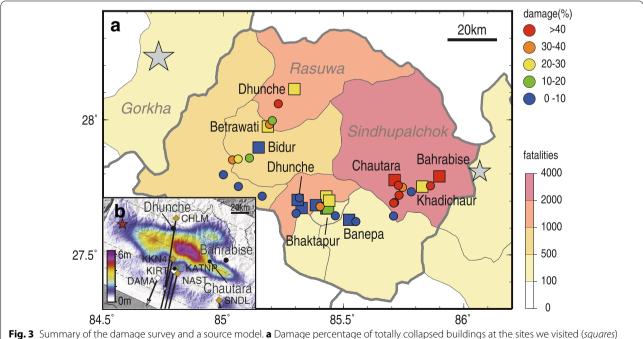
Next we focus on four major population centers (Kathmandu, Bahrabise, Chautara, and Dhunche) and describe the city properties, building types, and damage (see Figs. 5, 6).

Chautara is a municipality located 40 km east-northeast of Kathmandu and headquarters of Sindhupalchowk district. It is a city in a mountainous region with an elevation of approximately 1600 m above sea level. Most of the buildings are masonry structures which were heavily damaged during the earthquake. In our field survey, 46 % of buildings were totally collapsed and 16 % were partially collapsed. Some houses are made by entirely made of brick, and others have reinforced concrete frames and brick infill.

Dhunche is a village located 50 km north of Kathmandu and headquarters of Rasuwa district. It is a village within the Langtang National Park and was popular among hikers before the earthquake. The altitude of the village is about 2000 m. The Pasang Lhamu Highway, connecting Kathmandu and Dhunche, was heavily damaged by landslides induced by the earthquake. In our field survey, 27 % of buildings were totally collapsed and 25 % were partially collapsed. Most of the structures are made of brick, with or without reinforced concrete frames (EERI and IAEE 2015a).
