Characteristics of the surface ruptures associated with the 2016 Kumamoto earthquake sequence, central Kyushu, Japan

Yoshiki Shirahama^{1*}, Masayuki Yoshimi¹, Yasuo Awata¹, Tadashi Maruyama¹, Takashi Azuma¹, Yukari Miyashita¹, Hiroshi Mori², Kazutoshi Imanishi¹, Naoto Takeda¹, Tadafumi Ochi¹, Makoto Otsubo¹, Daisuke Asahina¹ and Ayumu Miyakawa¹

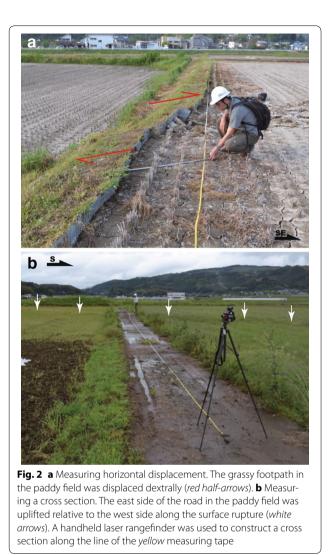
In this urgent survey, we needed to survey over 34-kmlong ruptures in short time. Because most of the ruptures appeared in inhabited areas, they were likely to be quickly erased by recovery works or weathering. We, therefore, decided to use a simple and primitive method for a measurement of displacement (Fig. 2) with an accuracy of 1 cm. To avoid underestimation of strike-slip displacement, we carefully selected reference markers (i.e., roads, footpaths between paddy fields, walls) which were long enough (20-30 m) to cover the deformation zone (generally <10 m) (Fig. 2a). For measuring slip on normal faults, we selected artificial or natural piercing points and measured displacements consisting of lateral, vertical, and extensional components. If there is any warping deformation away from the fault trace, this method would underestimate the total slip. At some points accompanied with warping deformation, therefore, we obtained topographic profiles with a handheld laser rangefinder to consider the total deformation. The uncertainty of our data depends strongly on the reliability of the selected piercing points or markers; therefore, we employed only clear

and obvious reference points. We expect the uncertainty of our data as a whole would not exceed $\pm 10\%$ of the total slip.

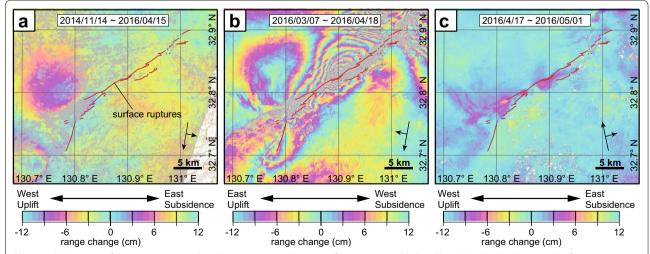
Our observations and eyewitness account from the Takano-Shirahata segment, and the southwestern section of the Futagawa segment showed that small cracks associated with the initial M_J 6.5 event on April 14 grew into primary ruptures with large slip during the mainshock. These observations were supported by interferometric synthetic aperture radar (InSAR) measurements (Fig. 7). Just after the initial event, widespread deformation was apparent at the west and northwest side of the Hinagu fault zone, but no significant deformation had occurred along the Futagawa and Hinagu fault zones (Geospatial Information Authority of Japan 2016d) (Fig. 7a). After the mainshock, major

slip had observed along these fault zones (Geospatial Information Authority of Japan 2016e) (Fig. 7b). We found evidence for further slip after the mainshock in the northern part of the Takano-Shirahata segment, where dextral slip of 50 cm as of April 16 had increased by 20% as of April 28, 12 days after the mainshock. Similar field observations were reported after the Napa earthquake of August 24, 2014 (Bray et al. 2014; Hudnut et al. 2014; Lienkaemper et al. 2016). In the case of Napa, afterslip amounted to 30-60% of the total slip. The temporal growth of surface ruptures associated with the Kumamoto earthquake were documented along both the Hinagu and Futagawa fault zones by geodetic surveys such as InSAR measurements (Fujiwara et al. 2016; Geospatial Information Authority of Japan 2016f) (Fig. 7c). These data suggest that when we measure the coseismic displacement, we need to survey in short time after the earthquake as our survey.
