Distribution and morphology of the surface ruptures of the 2018 Donggala–Palu earthquake, Central Sulawesi, Indonesia

A large Mw 7.5 earthquake occurred at 18.03 on 28 September 2018 in the Donggala–Palu area of Central Sulawesi, Indonesia, which triggered a tsunami, liquefaction, and landslides. A 160-km rupture zone was formed on the surface along the NS to NNW–SSE trending Palu–Koro fault (PKF) system through three regencies: Donggala, Palu, and Sigi. Obvious surface ruptures associated with the earthquake were not observed in the epicentral area. Surface ruptures with a small displacement of both sinistral and westerly downward slip components appear south of the epicentral area in the Donggala area. The event induced widespread subsidence of the Donggala coastal area on the west side of the rupture zone. Passing across the Palu bay, the rupture cuts through the urban area of Palu city and extends across alluvial fans along the western side of the Palu basin showing large displacements with a predominant sinistral slip up to 4.2 m and subordinate easterly downward slip components. Approximately 5 m of anomalously high vertical displacement with 3 m of horizontal displacement o

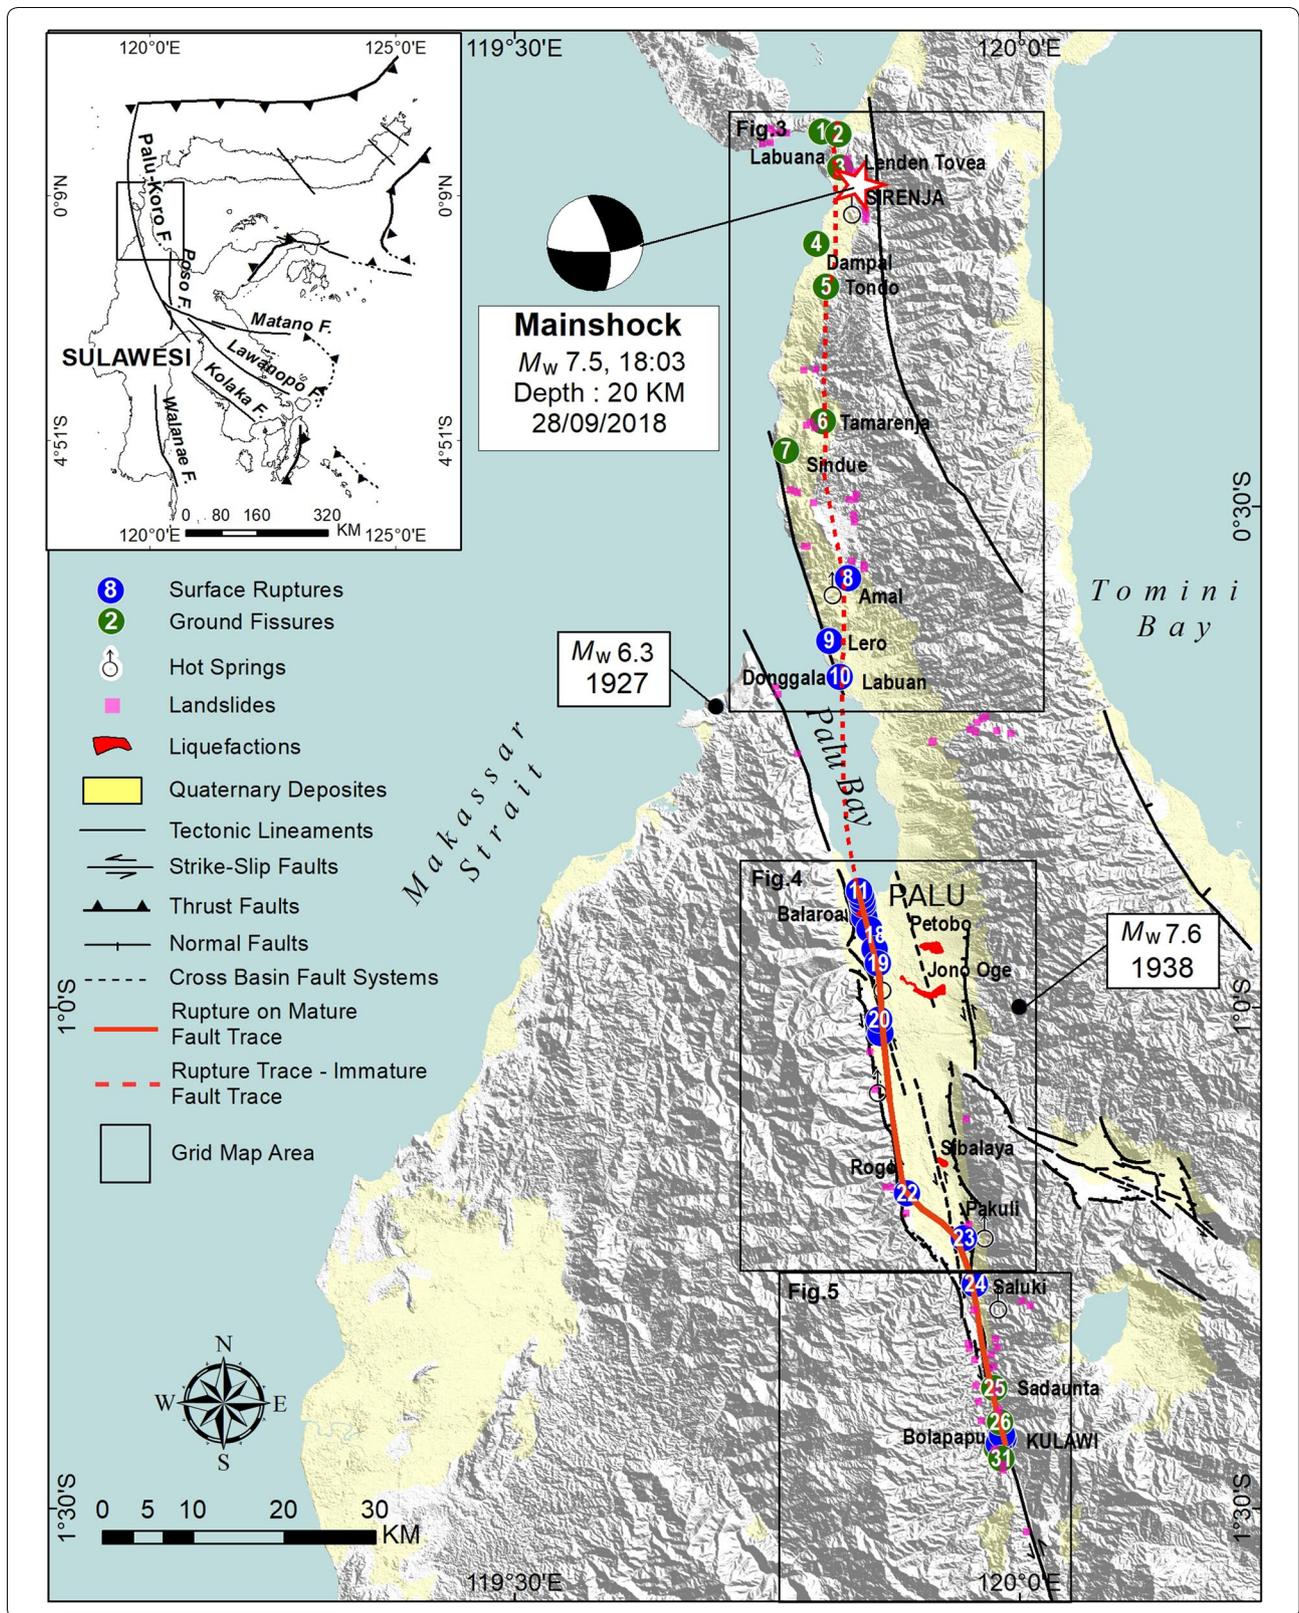
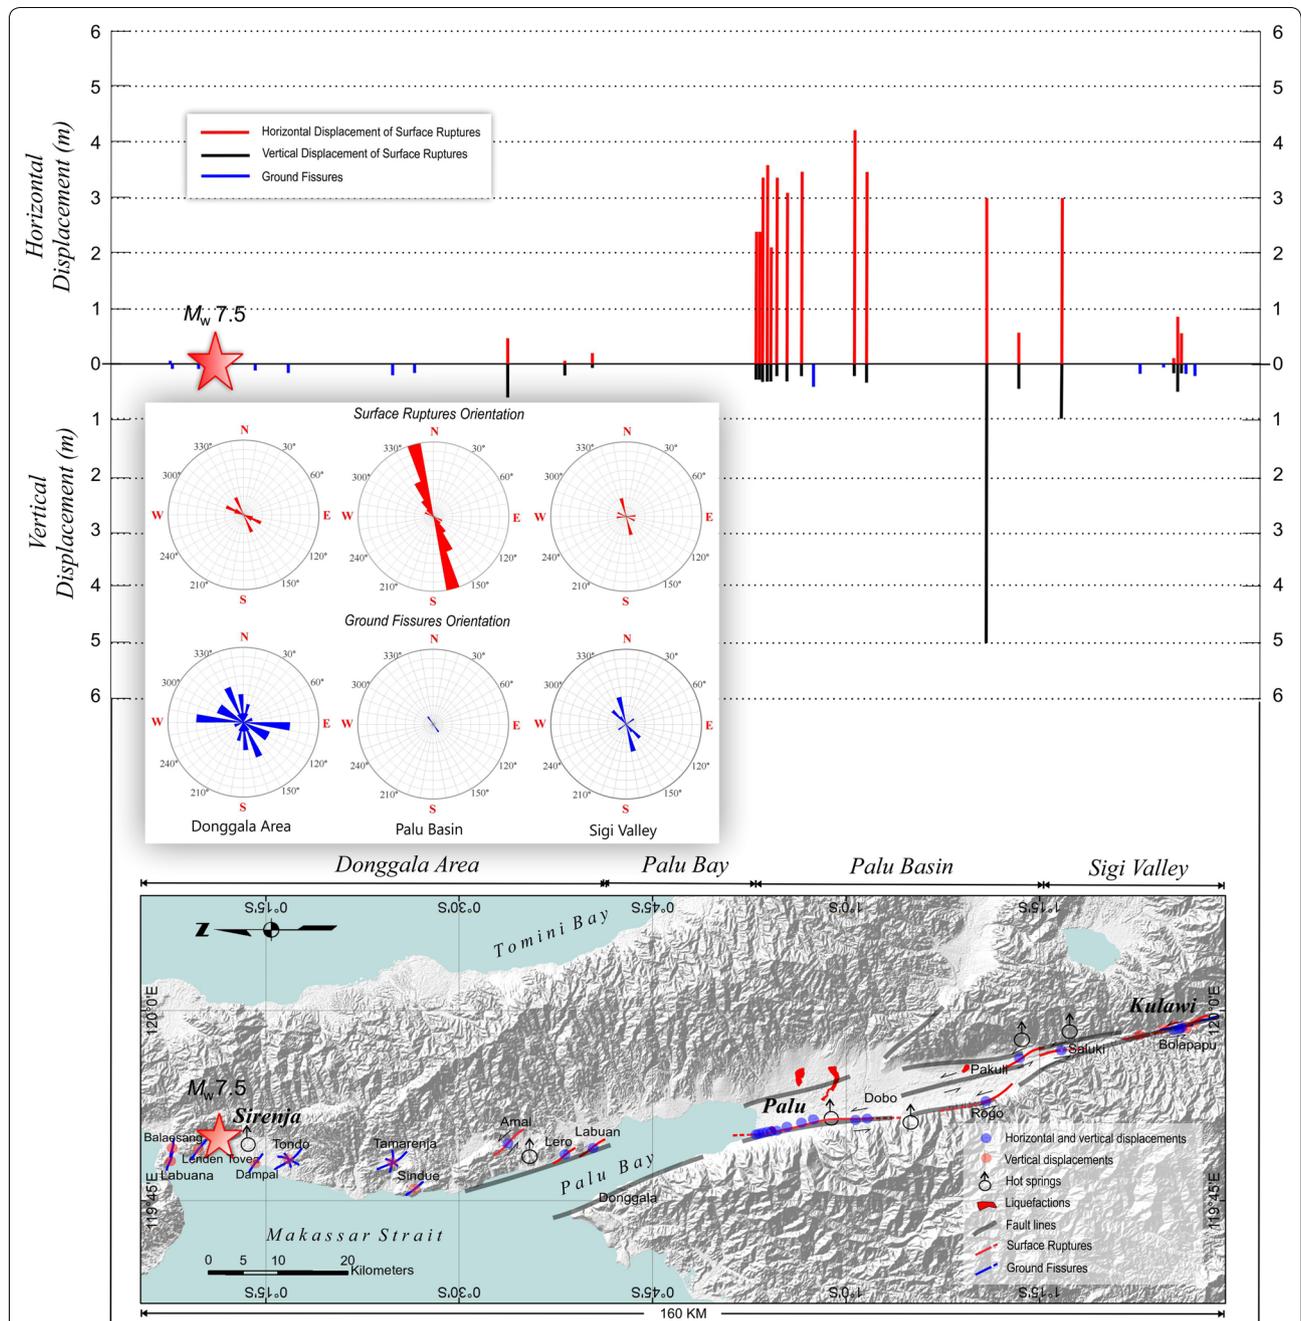
Fig. 2 Displacements of surface ruptures measured in the field. **a** Horizontal and vertical displacement along the surface rupture zone. Black column: surface rupture, grey column: ground fissures that are not confirmed as surface rupture. **b** Distribution of surface rupture formed by the 2018 earthquake (red line), ground fissure (blue line), and tectonic lineament of presumed fault (grey line). The length of ruptures and ground fissures showed on the map are exaggerated. The base map is a 30 m DEM-SRTM (USGS). Rose diagrams of fracture orientations are also shown. Original data to make distribution of surface rupture in Fig. 2 are compiled in Additional file 1

The epicentre of the mainshock of the 2018 earthquake is located 80 km north of Palu city (0.2559°S–119.8462°E). The rupture zone can be divided into two parts depending on general trend; the northern 80 km running through the Donggala regency from the epicentre to the Palu bay is N–S trending, while the southern part which passes through the Palu basin and Sigi valley shows NNW–SSE trend (Fig. 2).

A rupture zone cut through the western part of the Palu basin trending NNW–SSE (Fig. 2). Although the clear geomorphological feature suggesting a recent fault activity is recognised by straight mountain fronts and triangular facets in the western side of the basin, the new rupture zone does not follow it and runs several hundreds of

metres east of mountain base across the alluvial fans. Even though the distance from the epicentre is over 80 km, the horizontal displacement of rupture is largest around Palu city (Figs. 1, 2). We observed ruptures crossing the urban area (Fig. 4). A narrow zone with intense destruction and abrupt bending of the road is continuous for several kilometres southwards. The rupture zone is formed approximately 2.9 to 16.0 m wide and shows common sinistral and easterly downward slip sense. Horizontal and vertical components of slip range from 2.1 to 4.2 m and from 0.2 to 0.35 m, respectively (Figs. 1, 2, 4b, d; Table 1).

There is a bend section where rupture zone obliquely traverses across the southern part of the Palu basin, along a fault trace the red surface rupture trace that links Rogo with Saluki known as the Saluki fault trending NW–SE (Figs. 1, 2; PuSGeN 2017). We refer to this section as Rogo bend. At the west end of the Rogo bend, a steeply dipping rupture with anomalously high vertical displacement of 5 m and horizontal displacement of 3 m is observed (Fig. 4f). Net displacement is estimated approximately 5.8 m assuming vertical rupture plane. In the Rogo bend, ruptures show relatively large vertical displacement (Table 1).

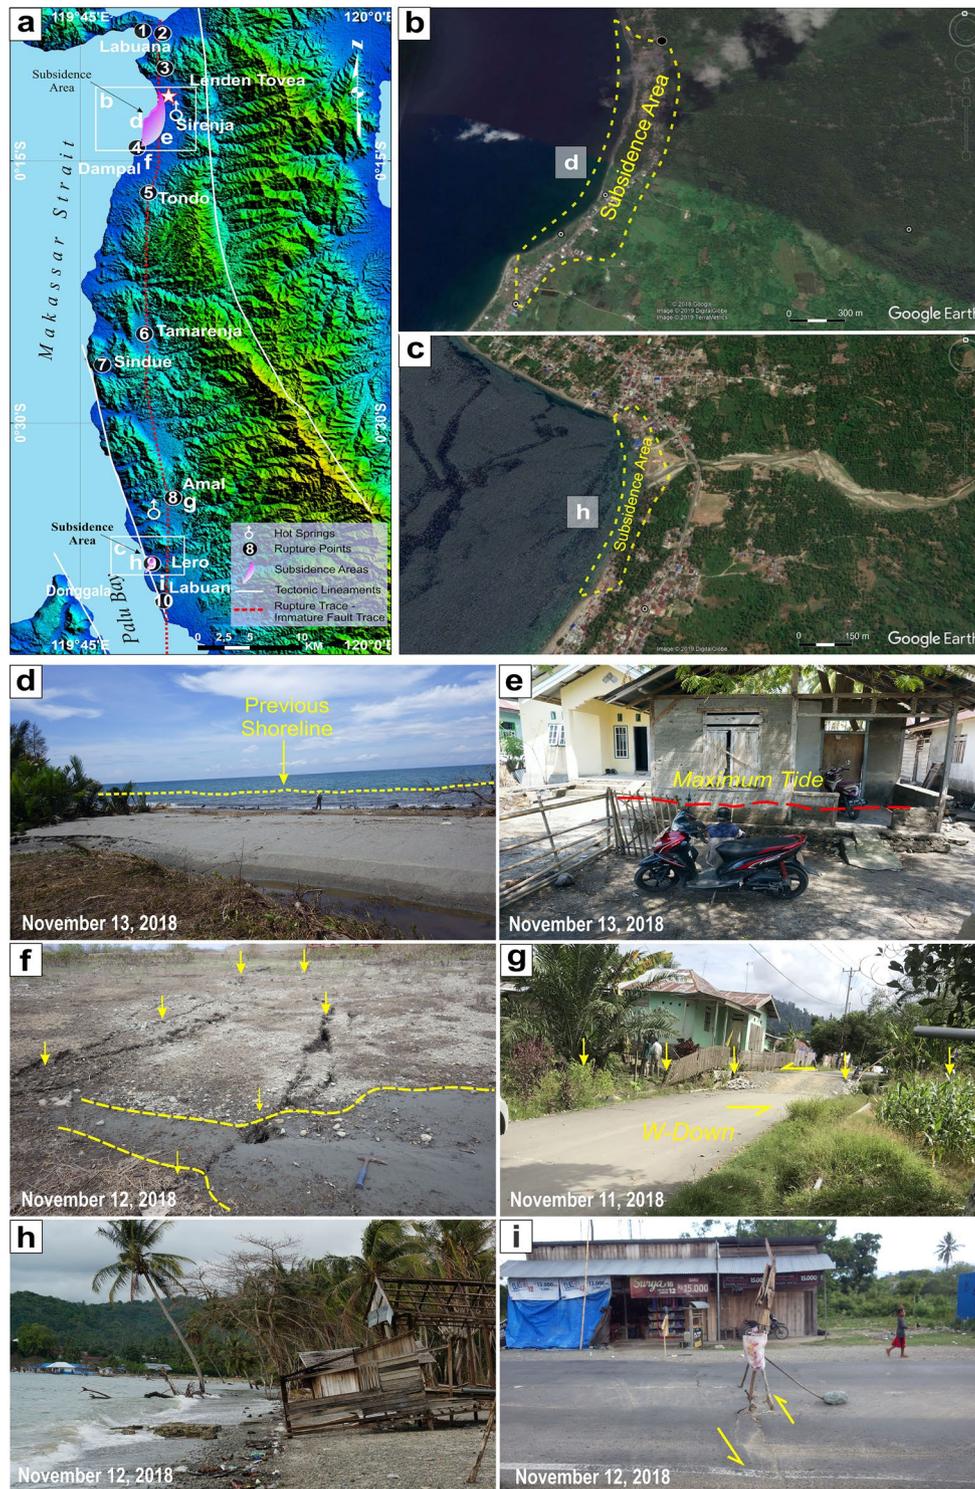
Fig. 3 **a** Site map of surface rupture, ground fissures, hot springs, and subsidence areas in the Donggala area. Structural lineaments are drawn after Watkinson and Hall (2017). The base map is a 30-m DEM-SRTM (USGS). **b** The subsidence area around Sirenja coastline (overlaid on Google Satellite imagery, darker updated from 2016 and lighter updated from 2018) and **c** Lero coastline (overlaid on Google Satellite imagery updated from 2018). **d** The shoreline retreated landward due to subsidence at Dampal-Lenden Tovea village. **e** Maximum tide as evidence of subsidence at Dampal-Lenden Tovea village. **f** Fissures and sand eruption at Dampal village. **g** A surface rupture cutting a road in Amal village. **h** The shoreline retreated landward and eroded houses and coastal forests due to subsidence at Lero village. **i** A displacement across the road at Labuan village

Around the epicentre and to the north, serious damages such as intense ground fissures, rock falls, landslides, destruction of houses and discharges of high-temperature hot springs that infer deep-reaching fractures, are distributed along an approximate N–S direction (Fig. 3f). In Dampal village close to the epicentre (Table 1), numbers of discontinuous and short ground fissures which orient NW–SE were observed in a dried coastal marsh. They accompany sand eruption indicating liquefaction (Fig. 3f). In the areas 8 km and 20 km south of epicentre (Tondo and Tamarenja villages; Figs. 1, 2, Table 1), ground fissures trending from NW–SE to NE–SW are formed concentrated in the zone of several tens of metres, respectively. However, in our surveys crossing the area where crustal movement is inferred from remote sensing images (e.g., GSI 2018), distinct surface ruptures were not observed.

A few displacement measurements were made for ruptures in several sites south of the epicentral area. In Amal village, approximately 40 km south of the epicentre, a clear NW–SE trending surface rupture zone is exposed linearly over 900 m in length (Figs. 1, 2, 3g; Table 1). At the site it crosses a road and a water channel, the main rupture almost vertical and striking about 300° shows sinistral and westerly downward slip with 0.4 m horizontal and 0.7 m vertical displacements in the flexural deformed zone of 3.2 m wide (Figs. 2, 3g; Table 1). In Lero and Labuan villages in the southern coastal area of Donggala area, NNW–SSE striking ruptures are exposed, both are single fractures and show almost vertical or steep dip and small offsets less than 20 cm in both horizontal and vertical displacements (Figs. 1, 2, 3i; Table 1). Observed horizontal slip senses are inconsistent with each other.

Coastal areas on the west side of the rupture zone are widely subsided. Although detailed mapping of subsidence has not yet been performed through the region, coasts near the epicentre (Sirenja coast) and the south end of the rupture zone in the Donggala area (Lero coast) show particular significance, where a transgression of coastline and a widespread flooding at high tide have occurred resulting from subsidence as much as 3 m since the 2018 earthquake (Fig. 3c, h).

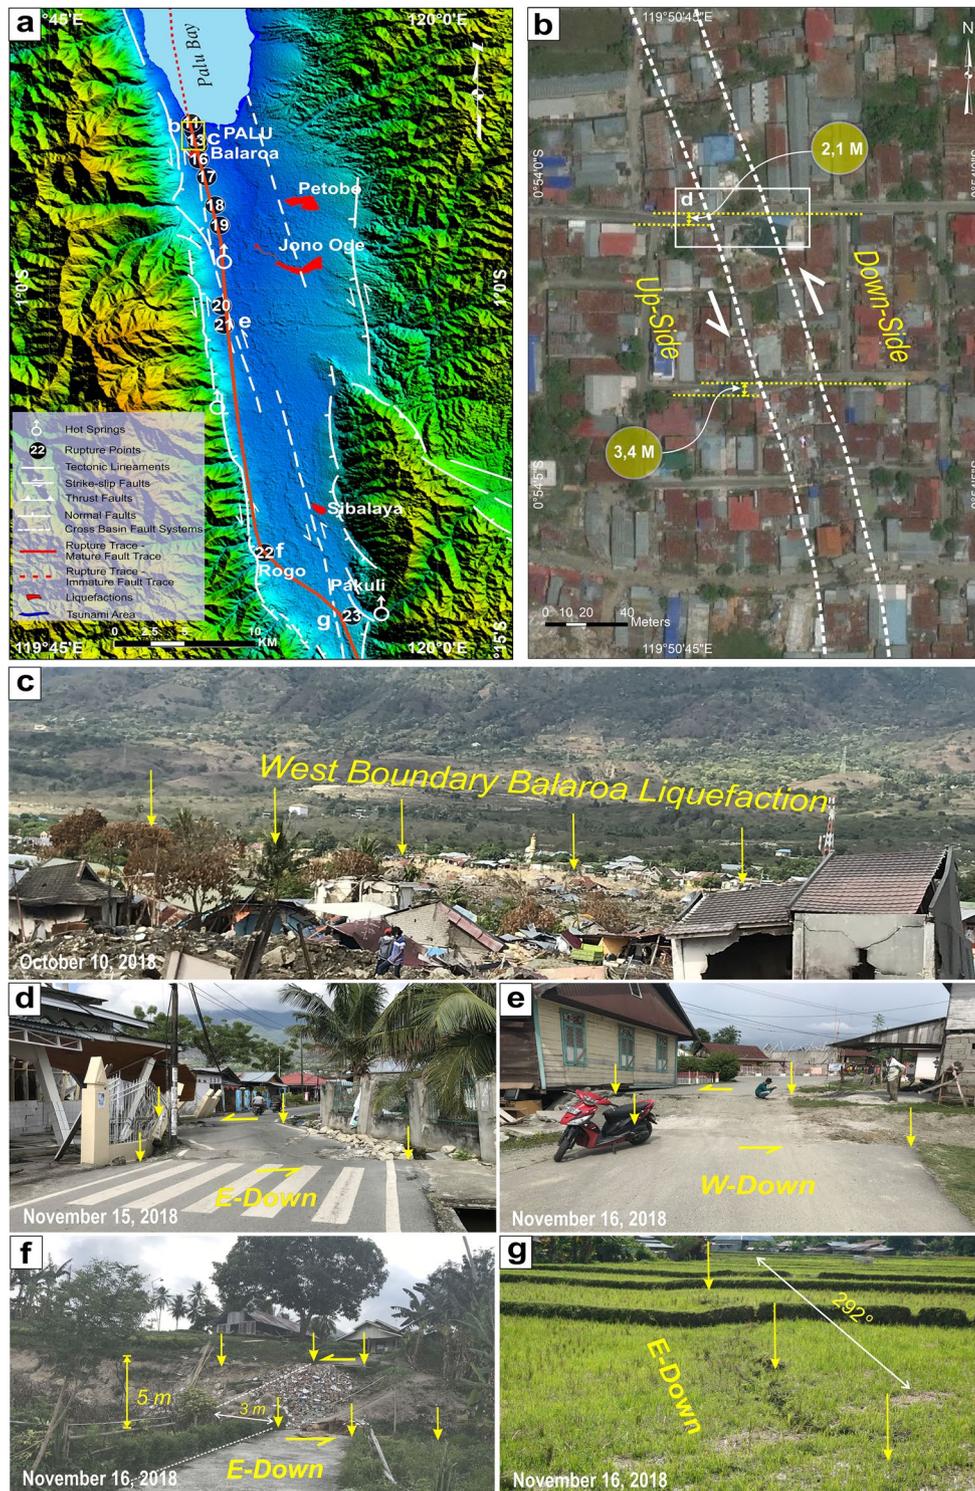
Fig. 4 **a** Site map of surface rupture, ground fissures, hot springs, and liquefaction areas in the Palu basin area. Structural lineaments are drawn after Watkinson and Hall (2017). The base map is a 30-m DEM-SRTM (USGS). **b** The rupture zone crossing the urban area of Palu city, in which constructions are seriously damaged. Abrupt bending of roads indicates a sinistral slip. (overlaid on Google Satellite imagery updated from 2018). **c** Liquefaction in the Balaroa area. **d** Surface rupture crossing Cemara 1 street in Palu city. **e** Surface rupture of Dolo Barat. **f** Surface rupture of Rogo village (5 m). **g** Surface rupture extending in a rice field in Pakuli village

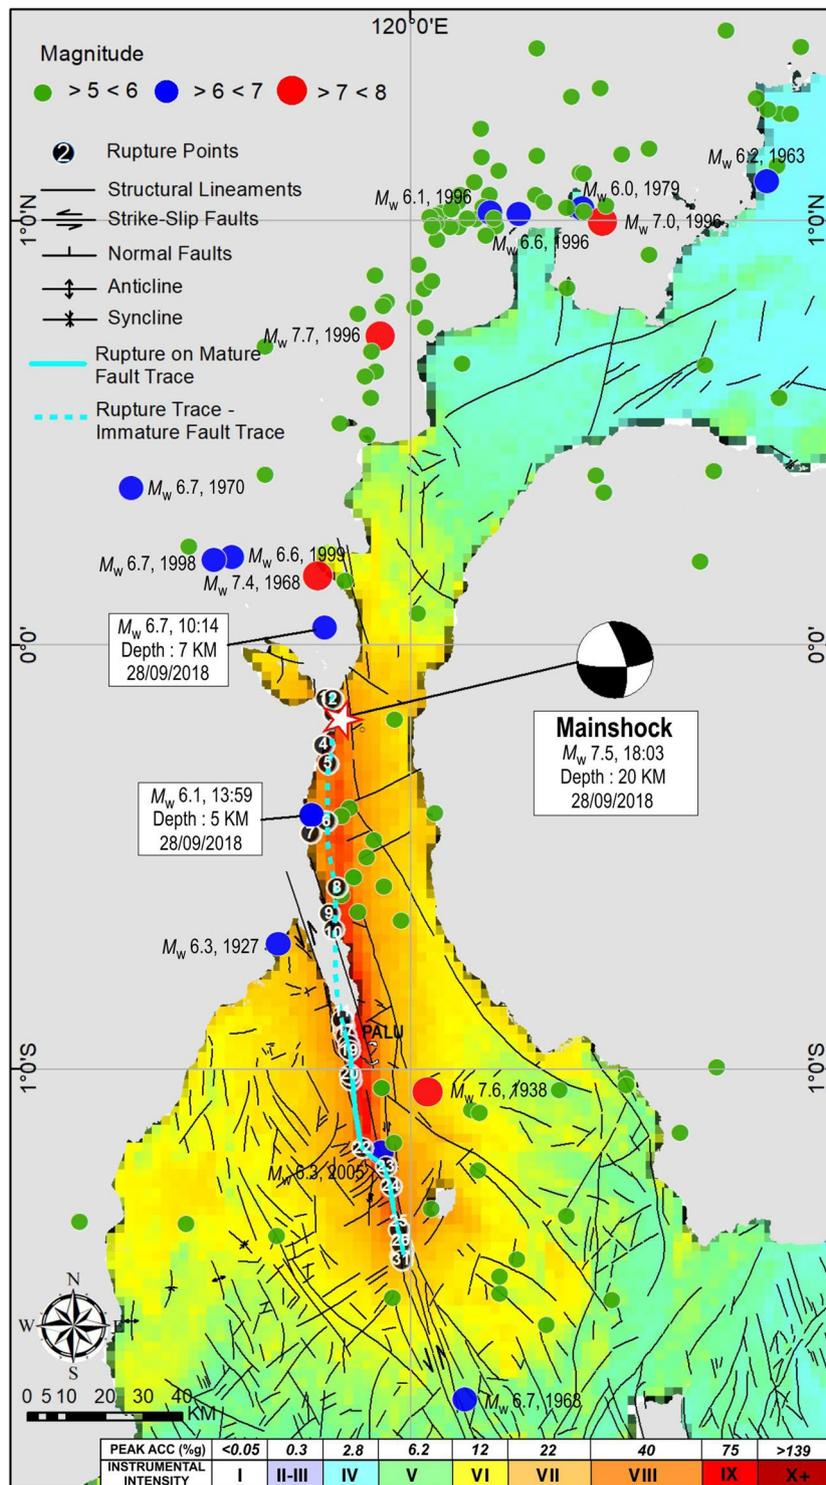
Fig. 6 Seismicity of Central Sulawesi area. Epicentres of moderate and large events (M_w 5–8) that occurred in shallow depth (< 35 km) from 1929 to 2019 are shown. Magnitude source: Pelinovsky et al. (1997); USGS, and Indonesian Earthquake Catalog, the based map: peak ground acceleration (PGA) by USGS (2018). Rupture trace inferred from radar satellite imagery is also shown as dashed line after Socquet et al. (2019). Structural lineaments are drawn after Ratman (1976), Sukanto (1973), Simandjuntak et al. (1991), Sukido et al. (1993), Watkinson (2011), Watkinson and Hall (2017)

In the past 100 years, a number of moderate and large earthquakes ($\leq M_w 7.7$) have occurred in Central Sulawesi area (Pelinovsky et al. 1997; Gomez et al. 2000; Prasetya et al. 2001, Fig. 6). However, the epicentres of these earthquakes are widely scattered over the regions, mostly distributed offshore or beyond the 2018 earthquake rupture zone. Previous studies predicted M_w

The extent and displacement of the rupture zone observed in our field survey are generally consistent with interferometric images of crustal deformation created from ALOS-2/PALSAR-2 data (Fig. 6; GSI 2018; Socquet et al. 2019), and slip displacement distribution based on GSN broadband waveforms provided by the USGS (2018). Nevertheless, a further detailed investigation is necessary for the elucidation of a precise rupture distribution, morphology, and crustal deformation associated with the 2018 earthquake (Additional file 1).
